Montana Department of
ENVIRONMENTAL QUALITY

RE: Corrective Action Management Unit (CAMU) Construction Inspections for July 6, 9, 10, and 16, 2001.

FIELD INVESTIGATION REPORT

SITE: ASARCO East Helena

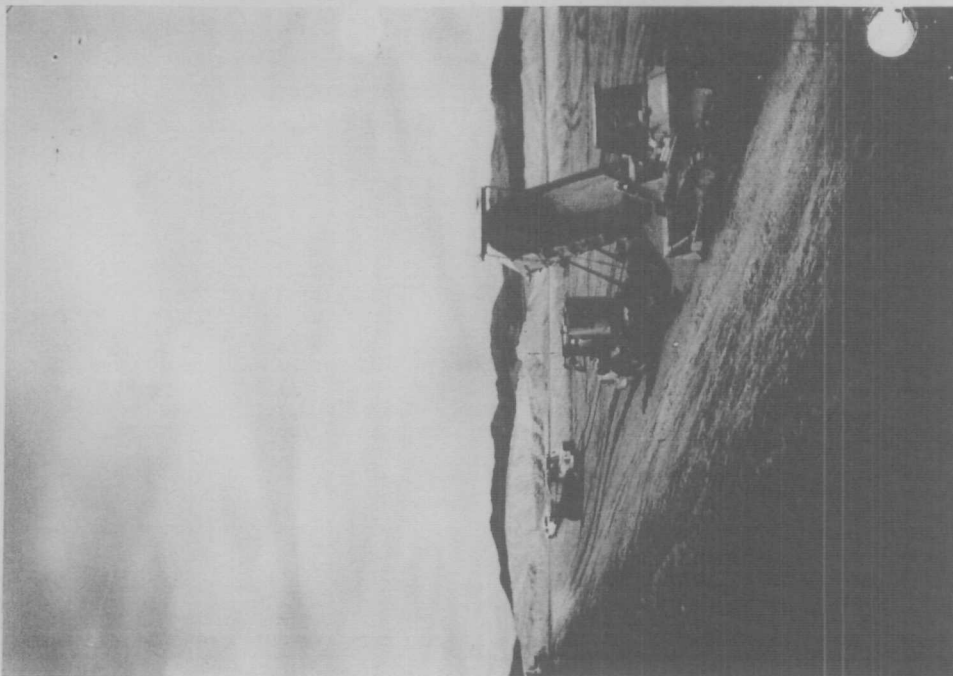
Darrel Shew and Kurt Wieringa (Envirocon construction supervisor) joined us. Mr. Shew said another screen with a higher process rate was suppose to arrive soon. Sand for the drainage layer was being delivered near the northwest edge of the CAMU. Mr. Wieringa stated they were going to start on the CAMU's northeast edge and work their way towards the southwest edge. This would allow the liner contractor to start work on the northeast edge as Envirocon worked their way to the southwest edge. Photo 1 shows a truck dumping clay liner material in the CAMU.

PROJECT/CASE NO: ASARCO E. Helena CAMU
 SUBJECT: Liner construction
 LOCATION: SE edge of CAMU looking SW; soil stockpiles
 in background
 CITY: E. Helena COUNTY: Lewis & Clark
 DATE: 07/09/01 TIME: AM
 WEATHER:(SUN)(HAZE)(**CLOUDY**)(RAIN)(SNOW)
 PHOTOGRAPHER (initials) Adel Johnson *aj*
 WITNESS: Susan Zazzali, EPA
 CAMERA: Vivitar Big View, BV35DB
 FILM TYPE: color ISO: 200
 NEGATIVE LOCATION: Attached to 07/16/01 CEI report
 PROCESSED BY: Montana 1 Hour Photo
 PHOTO# 1

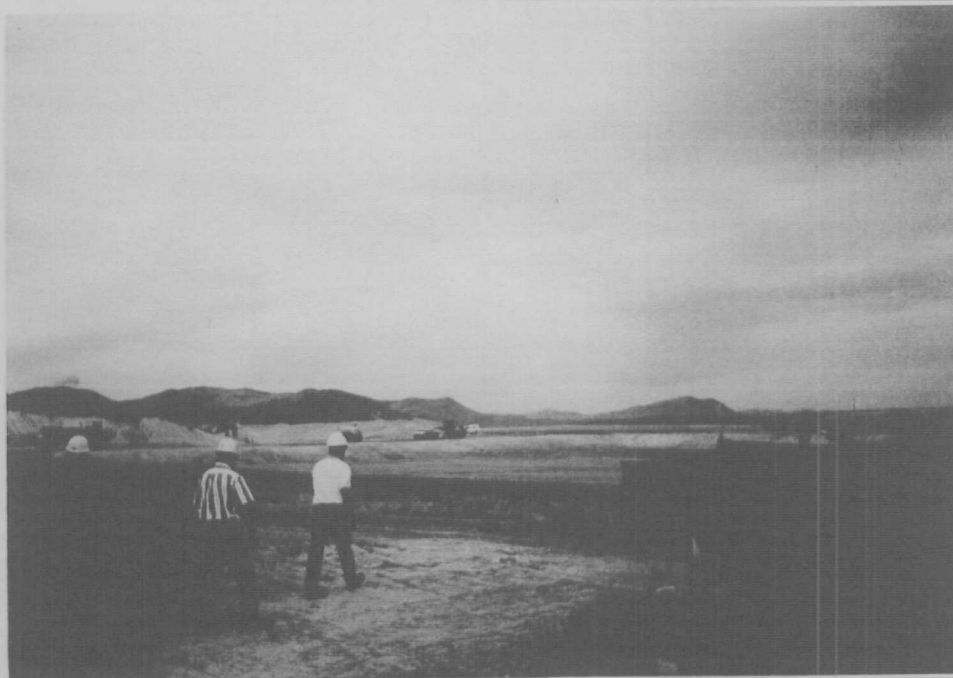
Some clay material that was pulled from the CAMU's bottom was placed on the CAMU's southeast edge. The wet material was being disked; however, it was being disked too deep causing large cobbles to be pulled in from underlying soil. Mr. Wieringa said the material was going to be left on this edge and compacted as part of the CAMU's toe. See photo 2 showing the disked material.

PROJECT/CASE NO: ASARCO E. Helena CAMU
 SUBJECT: Disking clay material
 LOCATION: SE edge of CAMU
 CITY: E. Helena COUNTY: Lewis & Clark
 DATE: 07/09/01 TIME: AM
 WEATHER:(SUN)(HAZE)(**CLOUDY**)(RAIN)(SNOW)
 PHOTOGRAPHER (initials) Adel Johnson *aj*
 WITNESS: Susan Zazzali, EPA
 CAMERA: Vivitar Big View, BV35DB
 FILM TYPE: color ISO: 200
 NEGATIVE LOCATION: Attached to 07/16/01 CEI report
 PROCESSED BY: Montana 1 Hour Photo
 PHOTO# 2

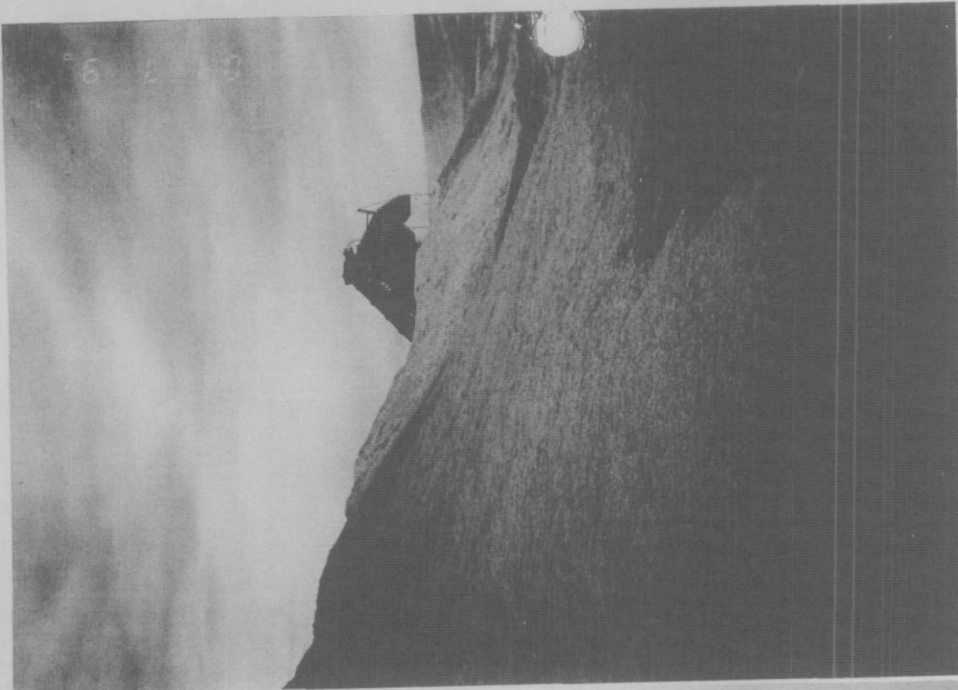
PROJECT/CASE NO: ASARCO E. Helena CAMU
 SUBJECT: Screening plant and screened material
 LOCATION: SW edge of construction site
 CITY: E. Helena COUNTY: Lewis & Clark
 DATE: 07/09/01 TIME: AM
 WEATHER: (SUN)(HAZE)(CLOUDY)(RAIN)(SNOW)
 PHOTOGRAPHER (initials) Adel Johnson *aj*
 WITNESS: Susan Zazzali, EPA
 CAMERA: Vivitar Big View, BV35DB
 FILM TYPE: color ISO: 200
 NEGATIVE LOCATION: Attached to 07/16/01 CEI report
 PROCESSED BY: Montana 1 Hour Photo
 PHOTO# 4

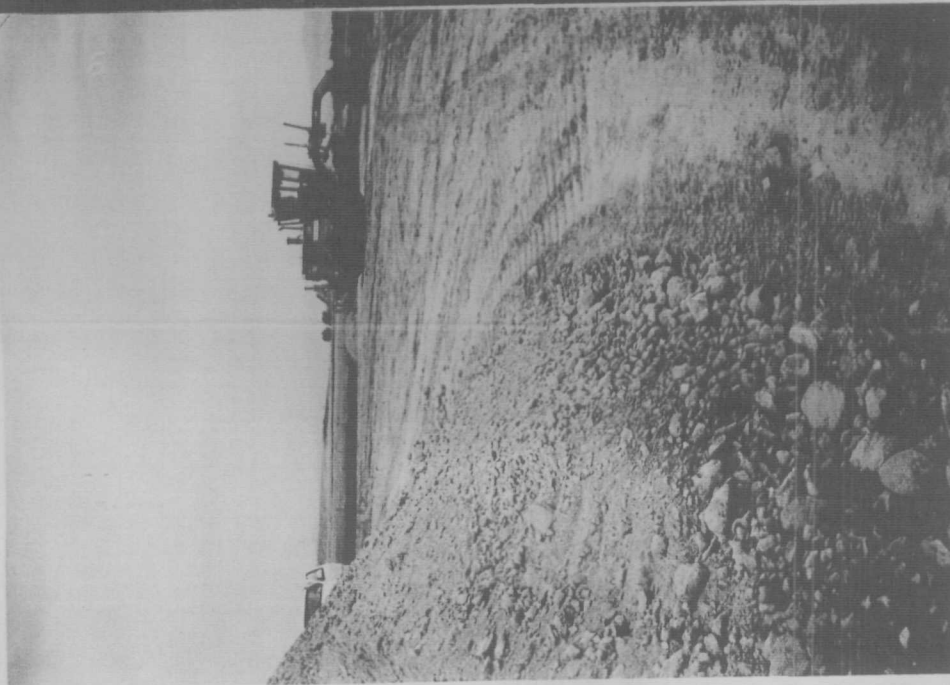
PROJECT/CASE NO: ASARCO E. Helena CAMU
 SUBJECT: Cobbles sorted from clay material; stormwater fence in background
 LOCATION: SW edge of construction site
 CITY: E. Helena COUNTY: Lewis & Clark
 DATE: 07/09/01 TIME: AM
 WEATHER: (SUN)(HAZE)(CLOUDY)(RAIN)(SNOW)
 PHOTOGRAPHER (initials) Adel Johnson *aj*
 WITNESS: Susan Zazzali, EPA
 CAMERA: Vivitar Big View, BV35DB
 FILM TYPE: color ISO: 200
 NEGATIVE LOCATION: Attached to 07/16/01 CEI report
 PROCESSED BY: Montana 1 Hour Photo
 PHOTO# 6

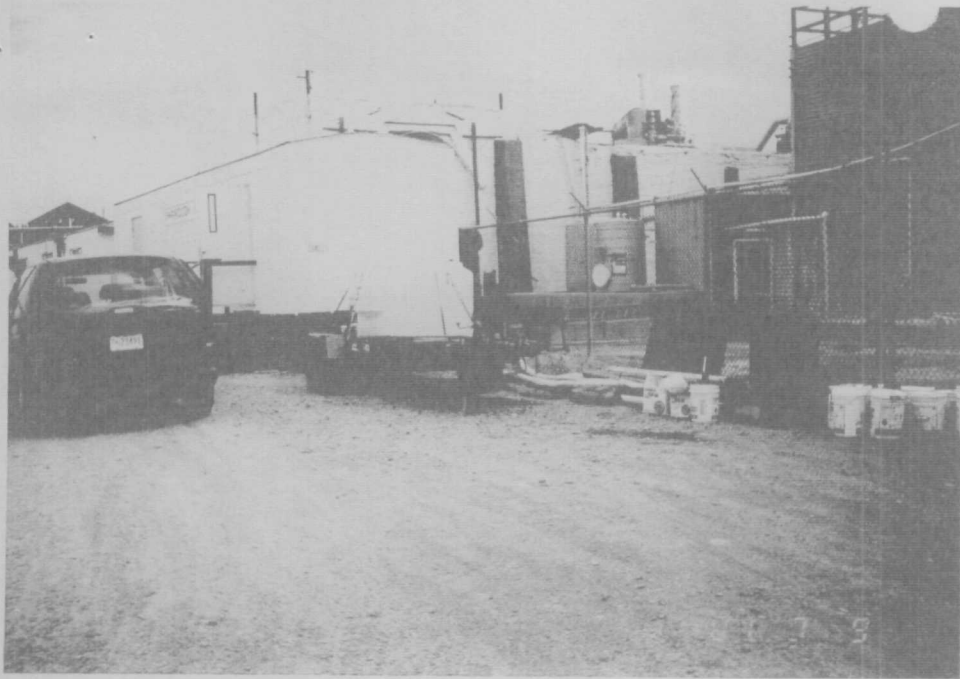
PHOTO# 15

Upon returning to the car the inspection team noticed several oil stained spots near the used oil drums. See photo 15. During the inspection on July 16, 2001, Mr. Wieringa was informed the stains needed to be cleaned-up.

SUBJECT: Used oil storage

RECOMMENDATIONS: Clean up the oil stained soil near the used oil drums.

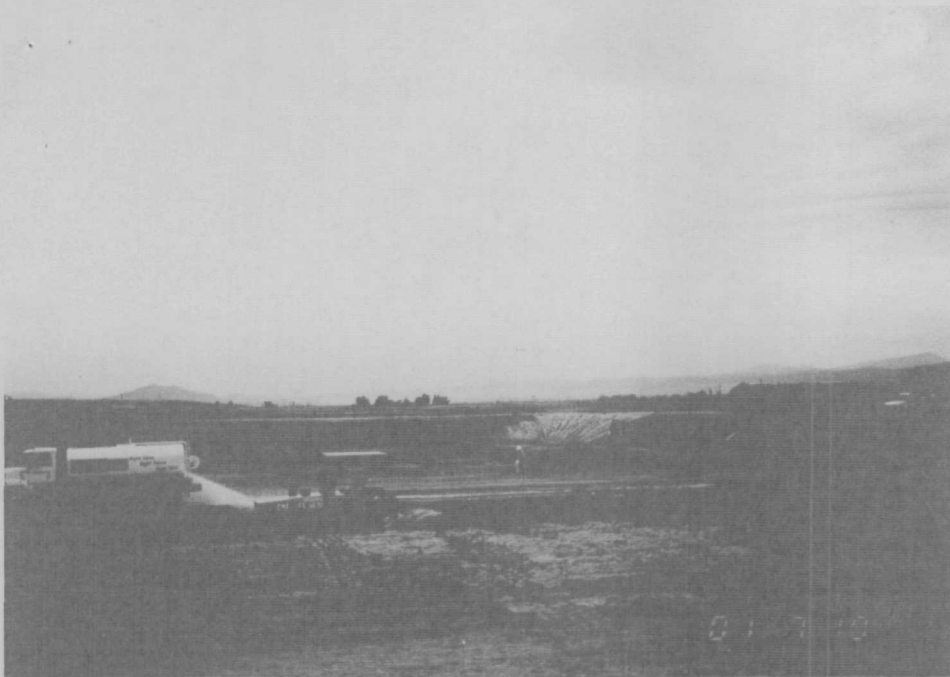
A CAT CS-563C roller compactor and a CAT CP-563D sheepsfoot compactor were in operation. These machines meet the specifications listed in the Contractor bid document. Photo 1 shows the roller compactor, watering truck, and grader working a lift and a bulldozer fixing the trench.

PROJECT/CASE NO: ASARCO E. Helena CAMU
 SUBJECT: Construction of clay liner
 LOCATION: SE edge looking N across
 CITY: E. Helena COUNTY: Lewis & Clark
 DATE: 07/10/01 TIME: AM
 WEATHER:(SUN)(HAZE)(CLOUDY)(RAIN)(SNOW)
 PHOTOGRAPHER (initials) Adel Johnson *aj*
 WITNESS: Susan Zazzali, EPA
 CAMERA: Vivitar Big View, BV35DB
 FILM TYPE: color ISO: 200
 NEGATIVE LOCATION: Attached to 07/16/01 CEI report
 PROCESSED BY: Montana 1 Hour Photo
 PHOTO# 1

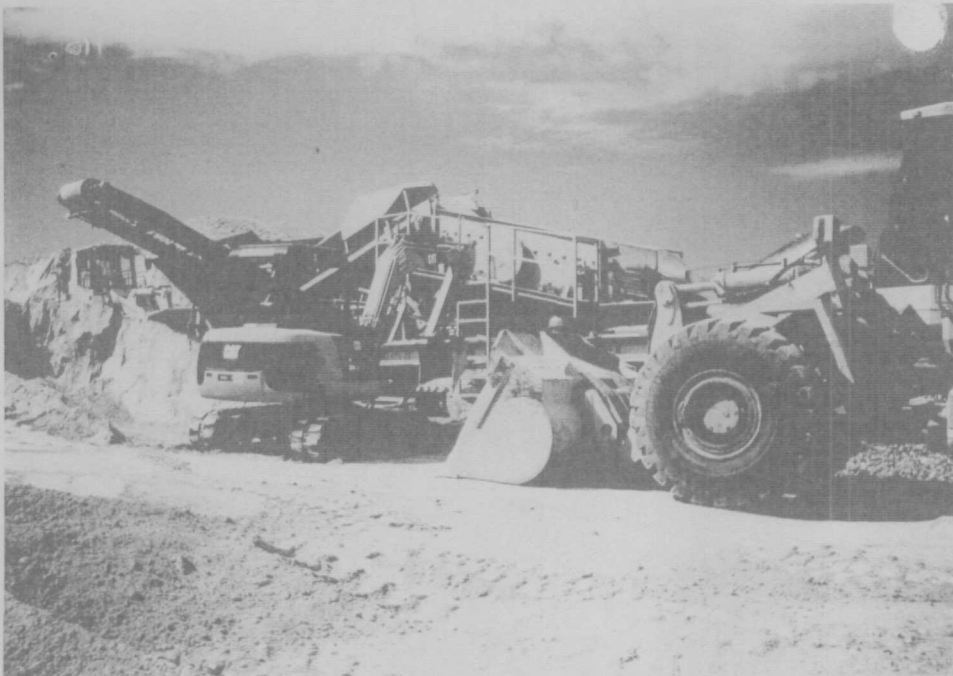
The inspection team proceeded to the screening operation. Photos 1 and 2 show the new screening plant. Mr. Wieringa stated the plant was not operating because of a broken belt. The liner contractor started working earlier that morning filling sandbags, but left because they could not start constructing

PROJECT/CASE NO: ASARCO E. Helena CAMU
 SUBJECT: New screening plant
 LOCATION: SW of CAMU
 CITY: E. Helena COUNTY: Lewis & Clark
 DATE: 07/16/01 TIME: AM
 WEATHER: (SUN)(HAZE)(CLOUDY)(RAIN)(SNOW)
 PHOTOGRAPHER (initials) Adel Johnson *AJ*
 WITNESS: Susan Zazzali, EPA
 CAMERA: Vivitar Big View, BV35DB
 FILM TYPE: color ISO: 200
 NEGATIVE LOCATION: Attached to CEI report
 PROCESSED BY: Montana 1 Hour Photo
 PHOTO# 1

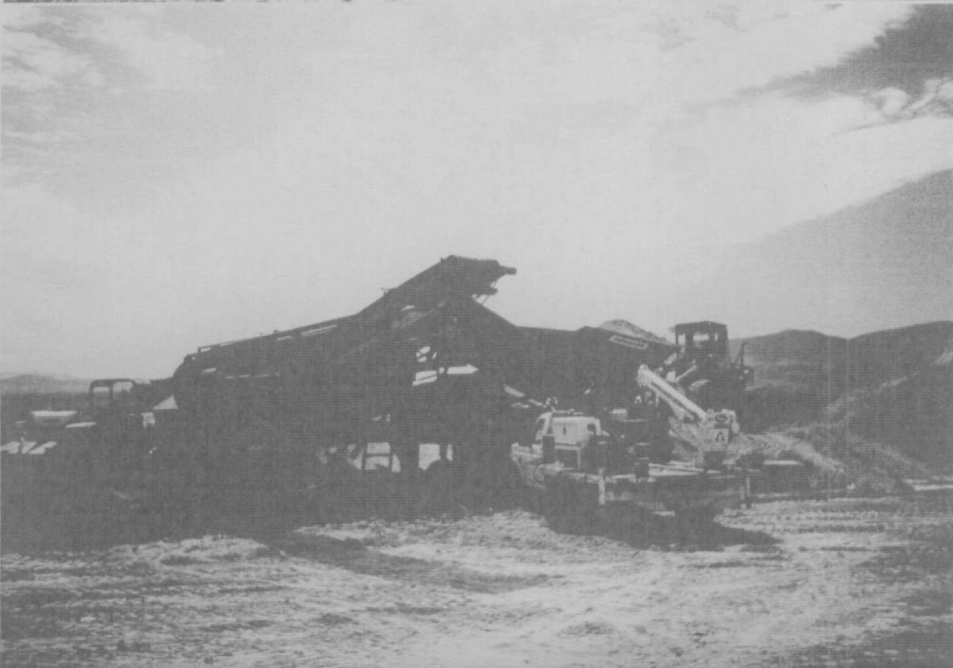
PROJECT/CASE NO: ASARCO E. Helena CAMU
 SUBJECT: Repairing new screening plant
 LOCATION: SW of CAMU
 CITY: E. Helena COUNTY: Lewis & Clark
 DATE: 07/16/01 TIME: AM
 WEATHER: (SUN)(HAZE)(CLOUDY)(RAIN)(SNOW)
 PHOTOGRAPHER (initials) Adel Johnson *AJ*
 WITNESS: Susan Zazzali, EPA
 CAMERA: Vivitar Big View, BV35DB
 FILM TYPE: color ISO: 200
 NEGATIVE LOCATION: Attached to CEI report
 PROCESSED BY: Montana 1 Hour Photo
 PHOTO# 2

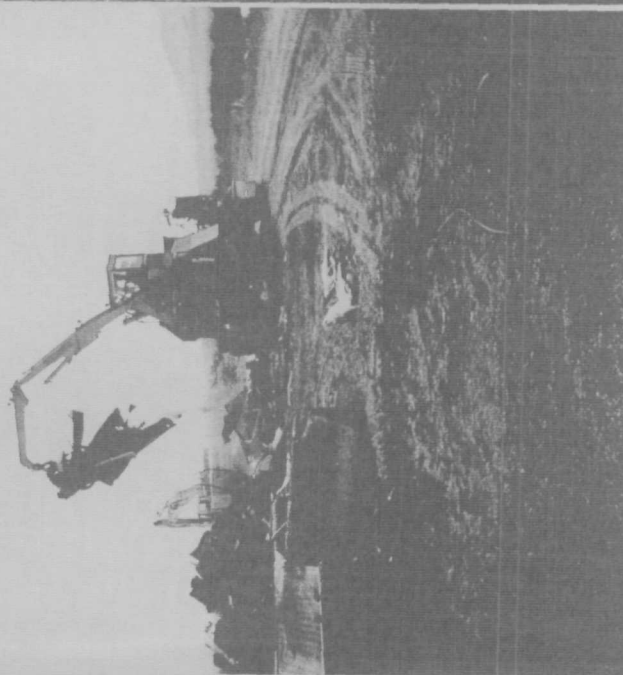
The inspection team drove through the contractor gates and parked west of the soil stockpile between Upper and Lower Lake. Two heavy equipment operators were sorting the pile and placing the metal scrap into a compactor. The compactor compressed the metal pieces into a block approximately 4 X 2 X 2 feet. The blocks will be placed in the CAMU. Photos 4 through 7 show the sorting/compaction process. One equipment operator was wearing a respirator and one was not. Later in the inspection Jon Nickel of Asarco, stated the operator's are allowed to choose whether they will wear a respirator.

PROJECT/CASE NO: ASARCO E. Helena CAMU
 SUBJECT: Sorting and compacting metal between Upper and Lower Lake
 LOCATION: S edge of pile looking E; Upper Lake on the right
 CITY: E. Helena COUNTY: Lewis & Clark
 DATE: 07/16/01 TIME: AM
 WEATHER: (SUN)(HAZE)(CLOUDY)(RAIN)(SNOW)
 PHOTOGRAPHER (initials) Adel Johnson *AJ*
 WITNESS: Susan Zazzali, EPA
 CAMERA: Vivitar Big View, BV35DB
 FILM TYPE: color ISO: 200
 NEGATIVE LOCATION: Attached to CEI report
 PROCESSED BY: Montana 1 Hour Photo
 PHOTO# 5

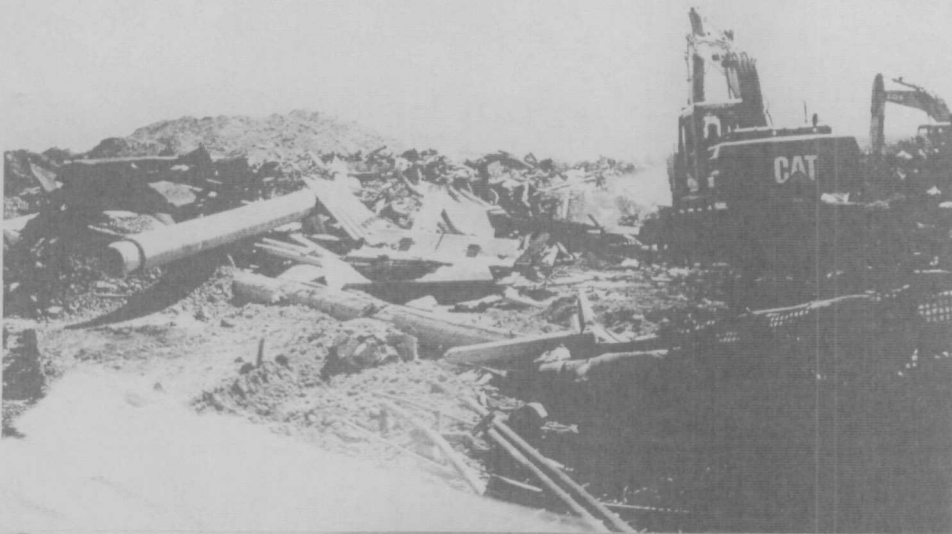
PROJECT/CASE NO: ASARCO E. Helena CAMU
 SUBJECT: Sorting material between Upper and Lower Lake;
 operator wearing respirator
 LOCATION: S edge of pile looking E
 CITY: E. Helena COUNTY: Lewis & Clark
 DATE: 07/16/01 TIME: AM
 WEATHER: (SUN)(HAZE)(CLOUDY)(RAIN)(SNOW)
 PHOTOGRAPHER (initials) Adel Johnson
 WITNESS: Susan Zazzali, EPA
 CAMERA: Vivitar Big View, BV35DB
 FILM TYPE: color ISO: 200
 NEGATIVE LOCATION: Attached to CEI report
 PROCESSED BY: Montana 1 Hour Photo
 PHOTO# 7
